Test Report

Electrical Test

MP-2022090008-V1.0

**power supply
motor with power supply**

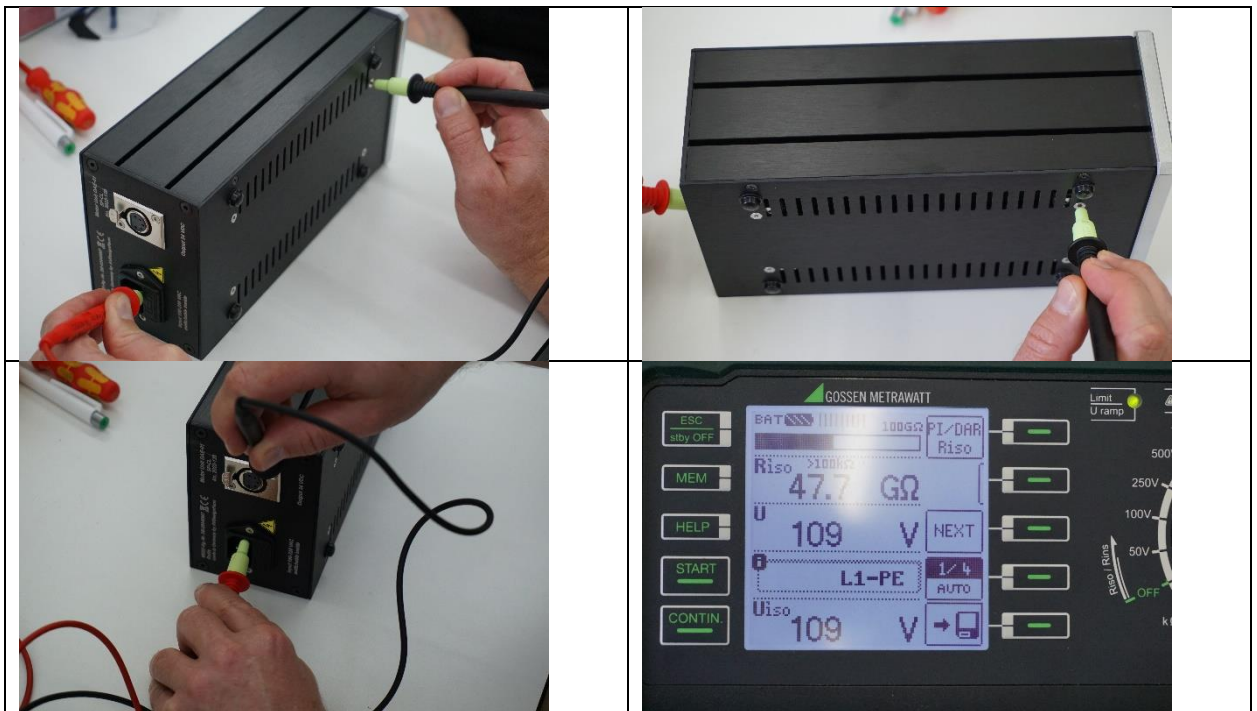
DUT-1

100V	47,7 GΩ
------	---------

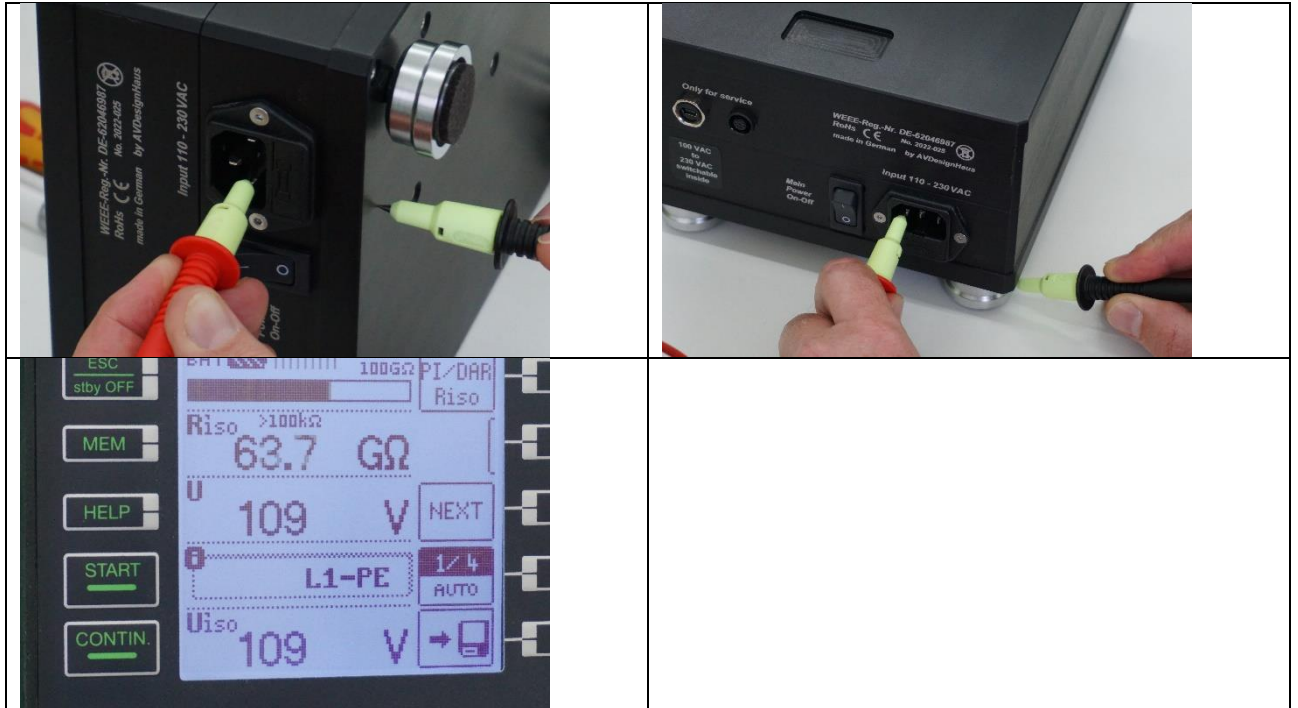
DUT-2

100V	63,7 GΩ
------	---------

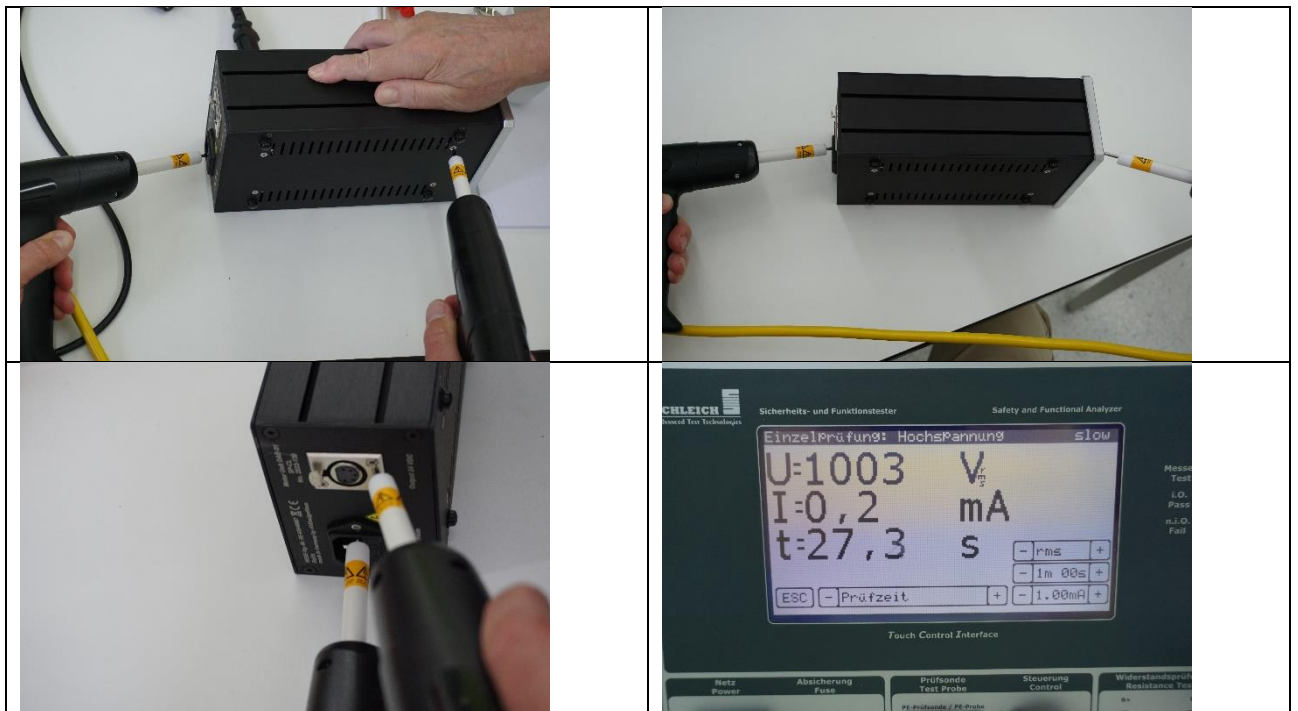
DUT-1

1000V	<0,2mA
-------	--------

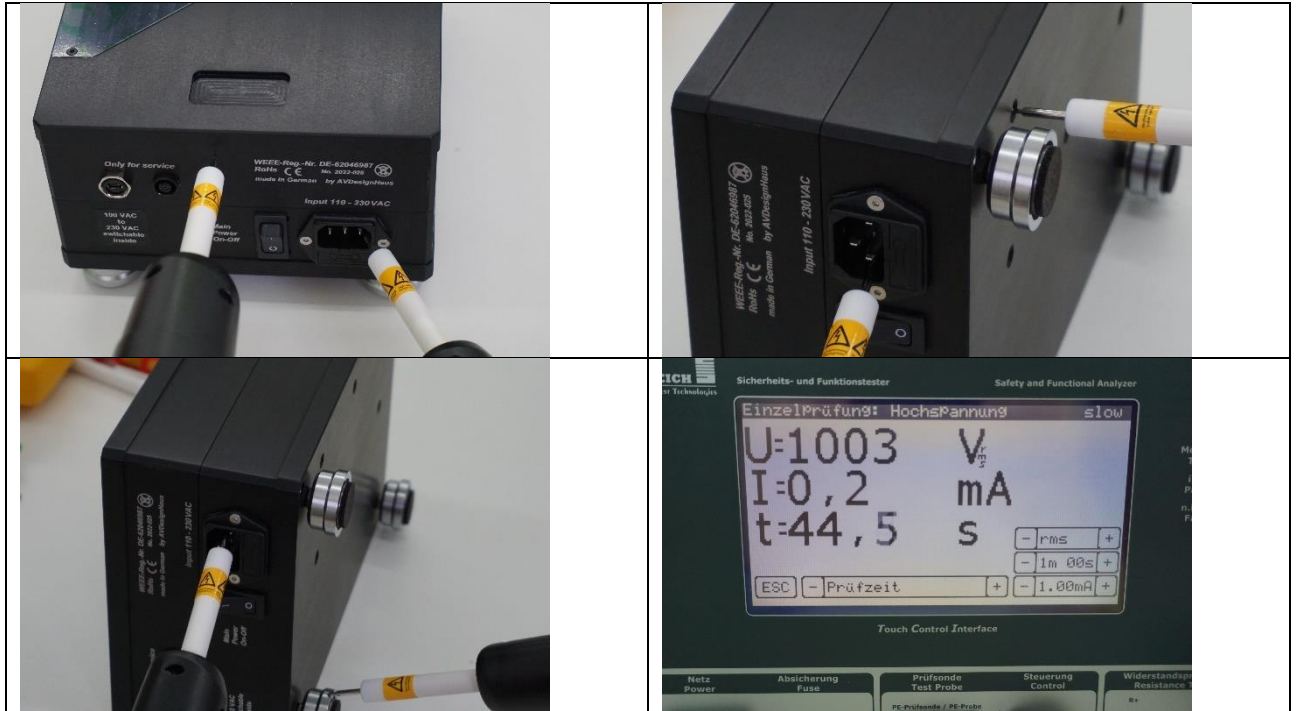
DUT-2

1000V	<0,2mA
-------	--------
